**DELTA ENGINEERING LTD**

## **Hazardous Building Material Assessment – Blueberry Patch, Inuvik, NT**

July 10<sup>th</sup>, 2026

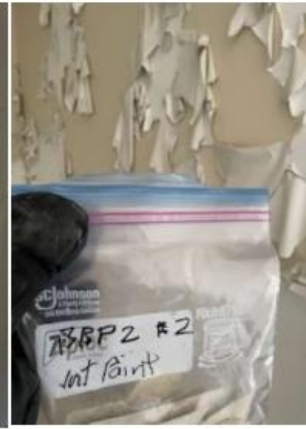
Image #2

Lead Content Paint sampling and analysis was conducted on the interior walls (Image #2) identifying Lead Content **above** mandated 80 mg/kg at **628** mg/kg. Follow up TCLP (Leachability) analysis of sample revealed leachability of **0.06** mg/L, thus well below the 5.0 mg/L mandated limit for disposal as general construction waste.

Note: It is recommended that any disturbance of High Lead containing painted products be conducted under a Hazmat format for protection of the Worker and Environment.
